The Rio Fernando de Taos Watershed Based Plan

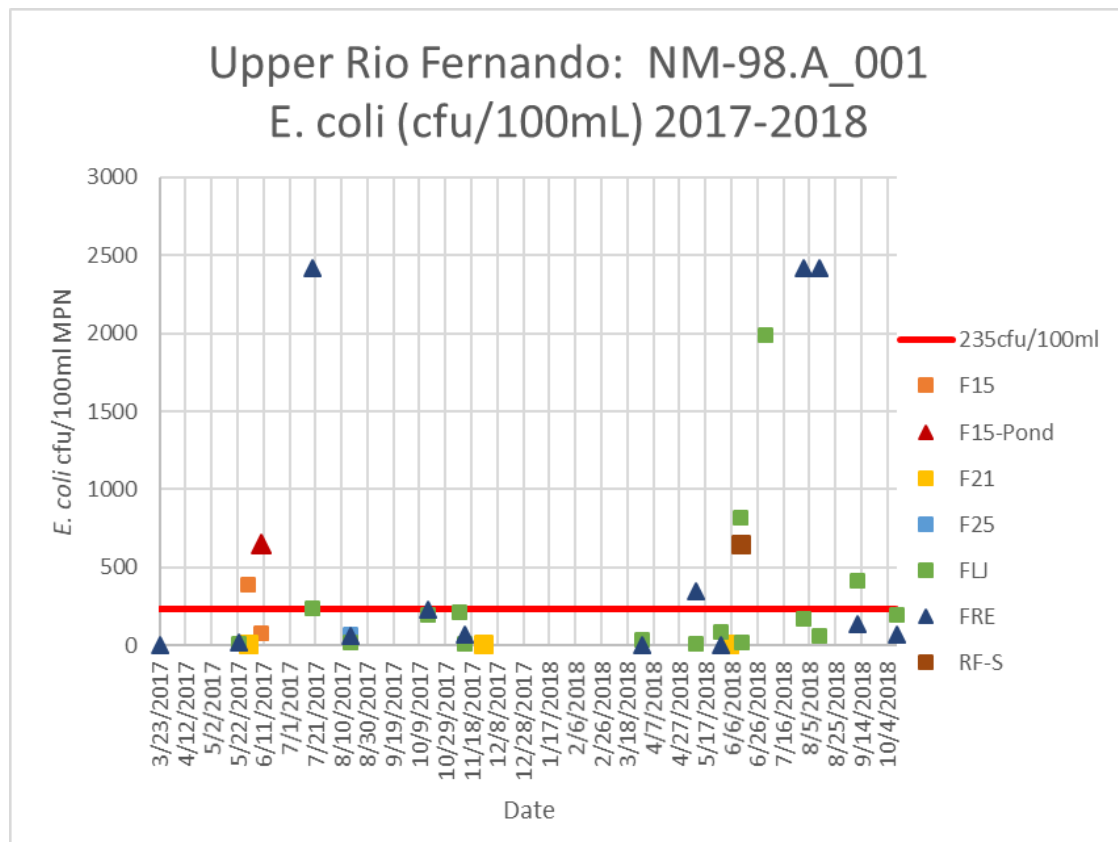
Figure 4-8: Upper Rio Fernando de Taos watershed *E. coli* results from March 2017 – October 2018.

Samples were collected every four to five weeks at six sites from March 2017 – October 2018 in the upper segment of the RFdT. In total, 40 *E. coli* samples were collected during this monitoring period. Of the 40 samples, 11 (27.5%) exceeded the single sample 235 cfu/100ml water quality standard. Review of data show a strong seasonal pattern observed with *E. coli* exceedances in this reach. All exceedances occurred during summer months with two in May, three in June, three in July, two in August, and one in September. Federal grazing in this reach of the watershed typically occurs from mid-June through September for a period of 107–120 days. Exceedances that occur prior to livestock presence in this area may be attributed to other potential sources such as wildlife, waterfowl, pet waste or older livestock fecal deposits. To better characterize the sources of *E. coli* in this segment, two sites FRE and FLJ, were selected as sample sites for the MST Study to estimate contributions from different sources.

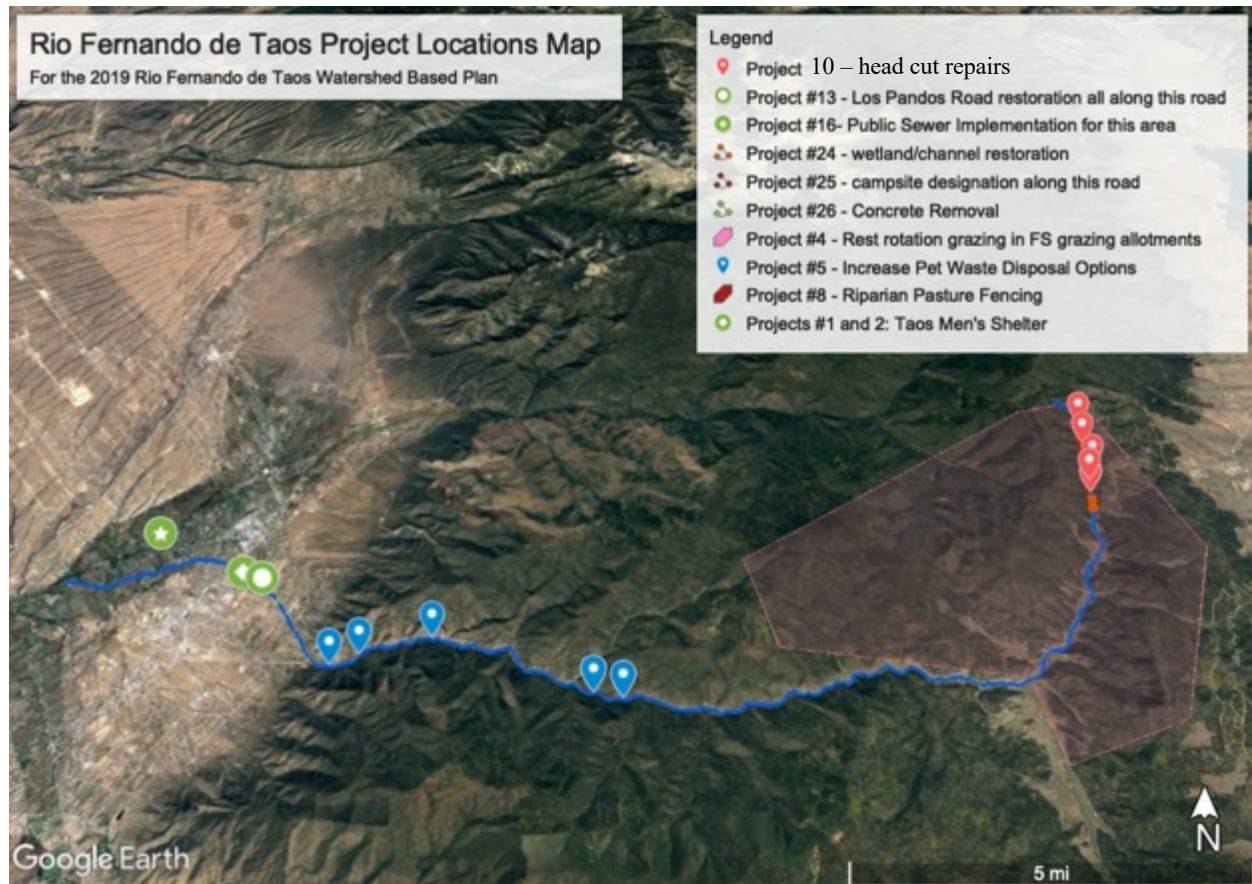
Figure 6-2: Map of each project using project numbers from the Project Table (Figure 6-1)

Projects with specific locations are shown on this map. Projects without specific locations can only be found in Figure 6-1. The upper, middle, and lower sections are separated by color.
