**APPENDIX A**

**MICROBIAL SOURCE TRACKING TO IDENTIFY FECAL CONTAMINATION  
SOURCES IN THE RIO FERNANDO DE TAOS**

**TAOS, NM**

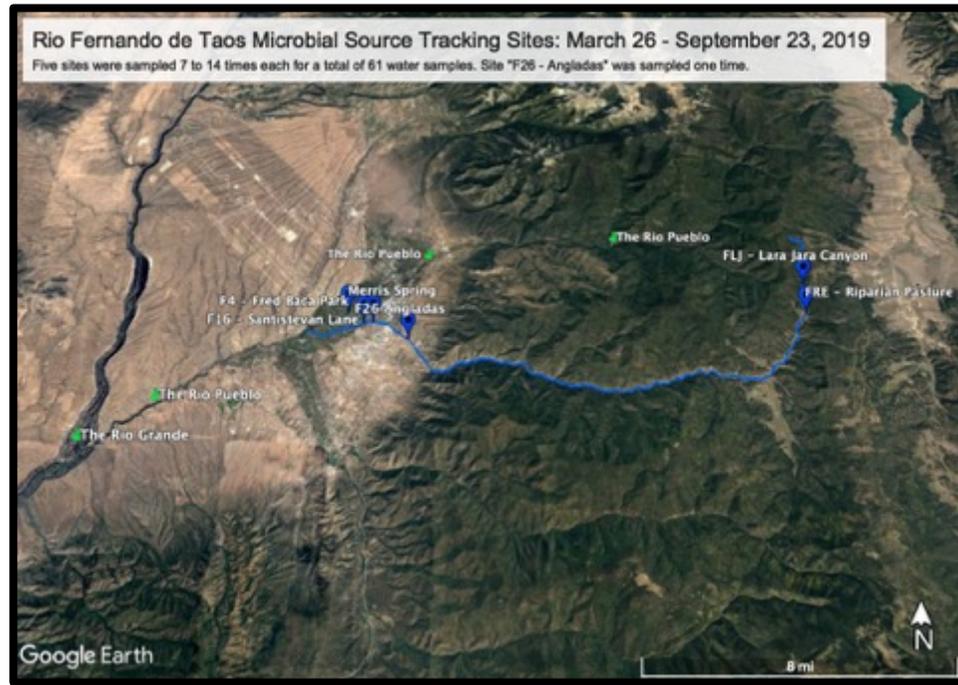
**Figure 3:** Rio Fernando MST Sample Site Map. Map of MST sampling locations. F26 was only sampled once. The other five sites were sampled 7-14 times based on water availability. Sites chosen indicate there has been an on-going *E. coli* problem in that location and more information about the source was needed.
