# The Rio Fernando de Taos Watershed-based Plan

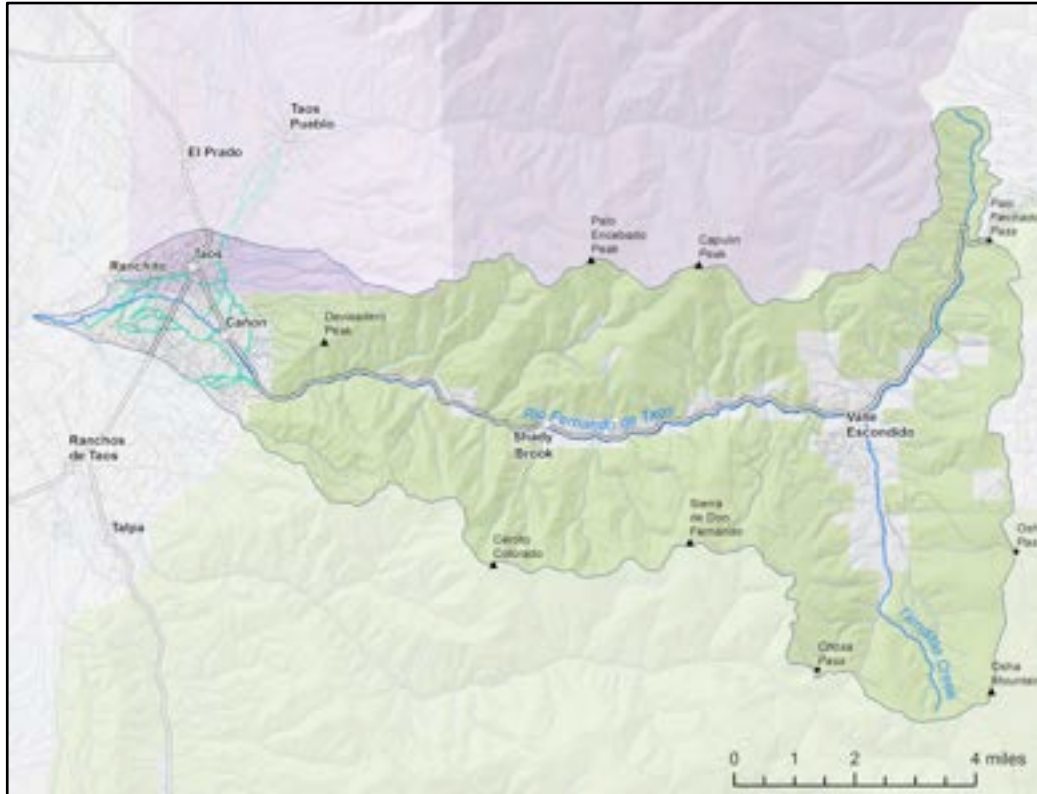
**Figure 3-1: Rio Fernando de Taos Watershed Area**

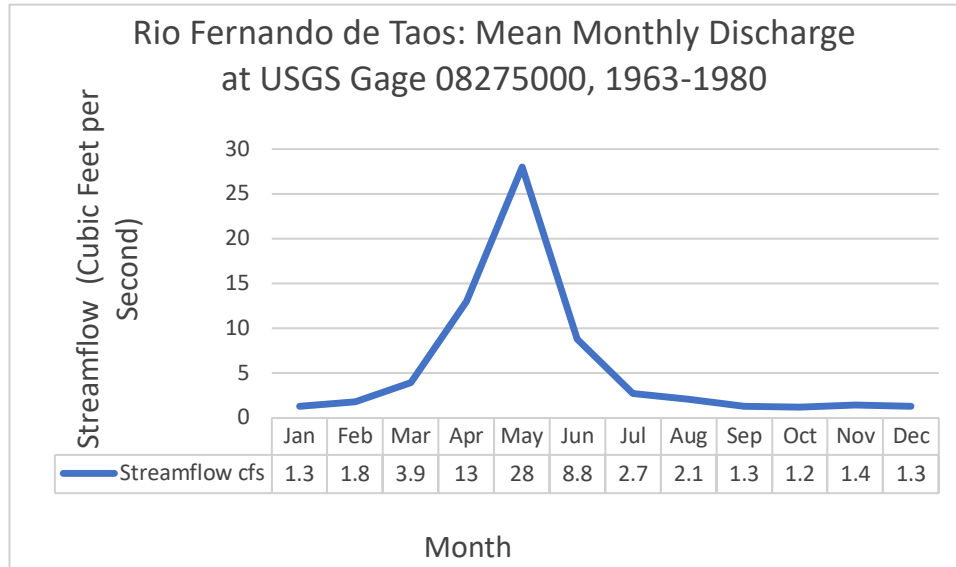
**Figure 3-4: Hydrography Data of RFdT at USGS Gage Station 08275000**

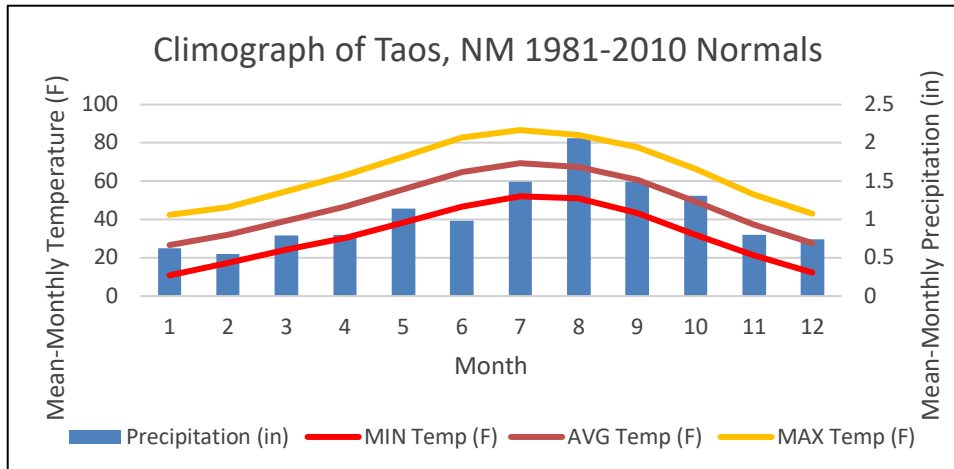
Figure 3-7: Town of Taos Climograph; Data collected at Taos Climate Station: Elevation 6,985 feet. Climate Normals generated by National Climatic Data Center of NOAA (NOAA 2010).

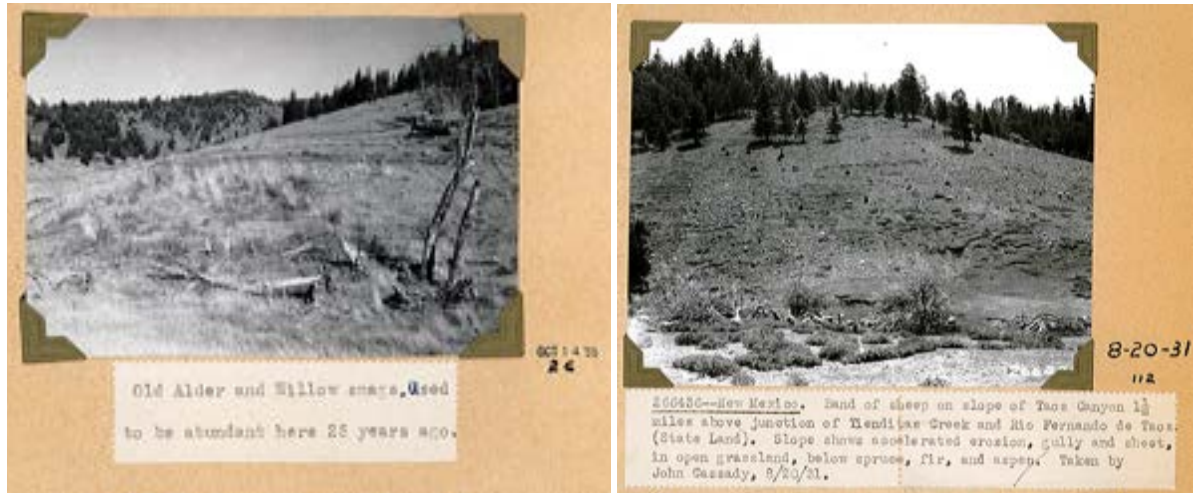
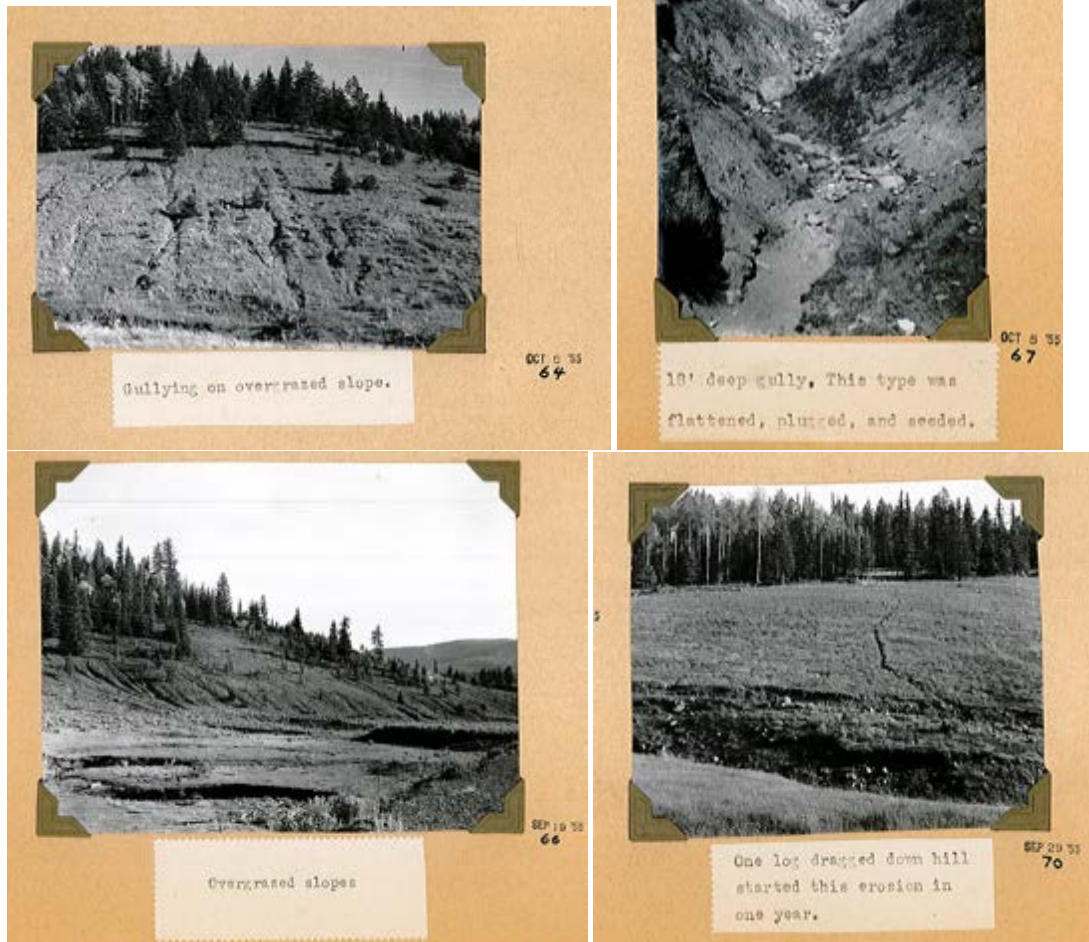
**Figure 3-15: US Forest Service photos showing example of resource overuse in the area. Photos are from 1931-1955 (USFS Photobook 1962).**

*“veritable no-man lands while they were administered as New Mexico State leases...Anyone in the Taos Valley who did not have summer range brought cattle, horses, sheep, goats and burros to the Tienditas State lands. Since competition was so great for forage produced, the livestock was brought to these units as soon as snow started melting. Much soil loss and compaction resulted. By the fall of the year, most of the livestock had been removed because of a lack of forage, even steeper slopes were devoid of all palatable forage” (USFS, 1950).*

In 1950, the United States acquired the Tienditas State lands, and administration of the land was placed under the USFS. Over time, rampant over-grazing and poorly administered timber harvest had severely degraded the area and were major sources of NPS pollution in the upper portions of the RFdT. As described above, prior land use had left much of the upper watershed devoid of vegetation and susceptible to erosion which in turn led the USFS to initiate grazing reforms and watershed improvements which can be credited as the primary turning point in watershed restoration.

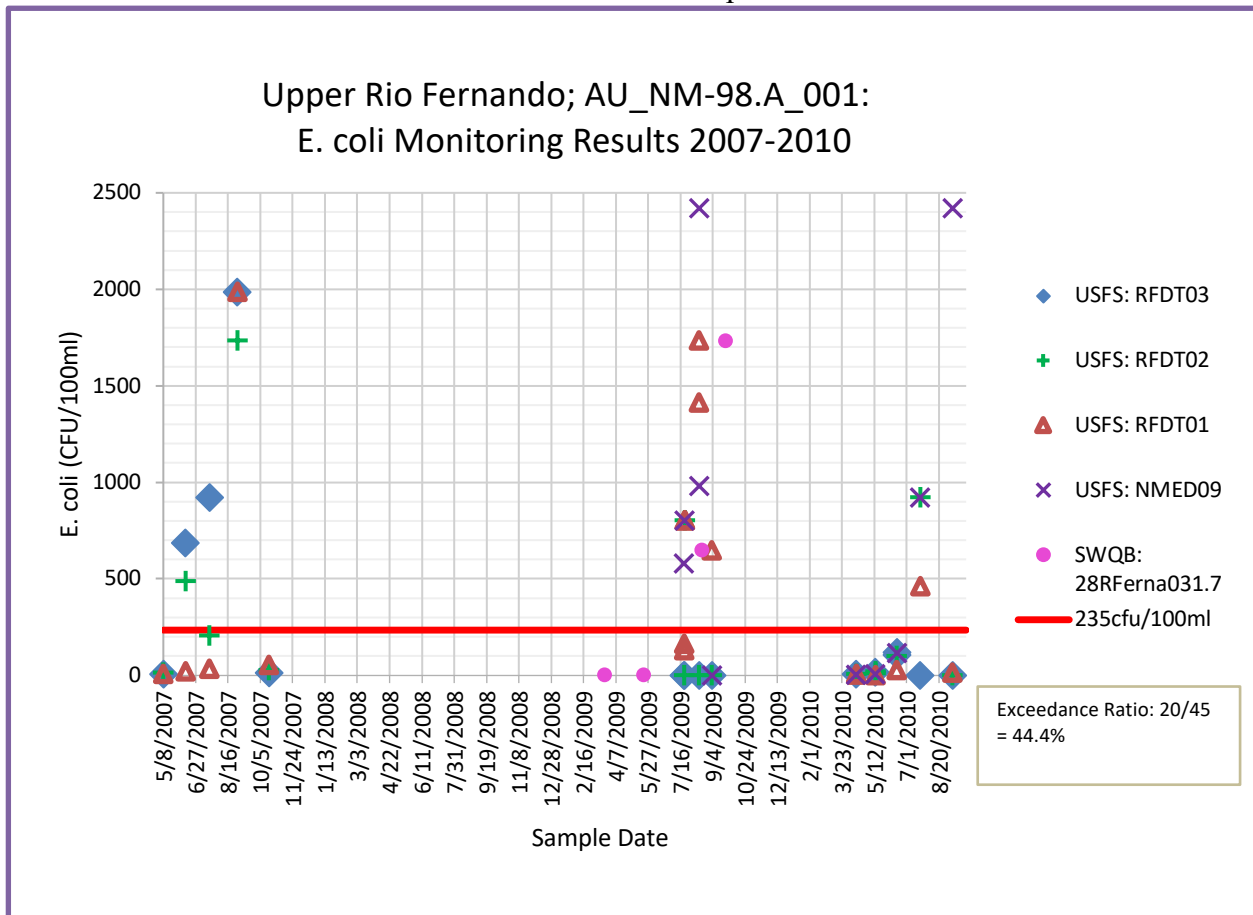
Figure 4-1: *E. coli* results from USFS Carson National Forest in cooperation with SWQB on the upper segment in 2007 and 2009–2010.

In the upper segment of the RFdT, AU\_NM-98.A\_001, NMED's SWQB Watershed Protection Section completed a special study of *E. coli* levels associated with flow observation to assess potential impacts from livestock grazing in 2006. The study demonstrated instances when livestock grazing on the Flechado Allotment probably increased *E. coli* levels in this segment of the RFdT (NMED 2012). The USFS Carson National Forest in cooperation with SWQB sampled for *E. coli* on this segment in 2007 and 2009–2010 which is displayed in the graph above. In total

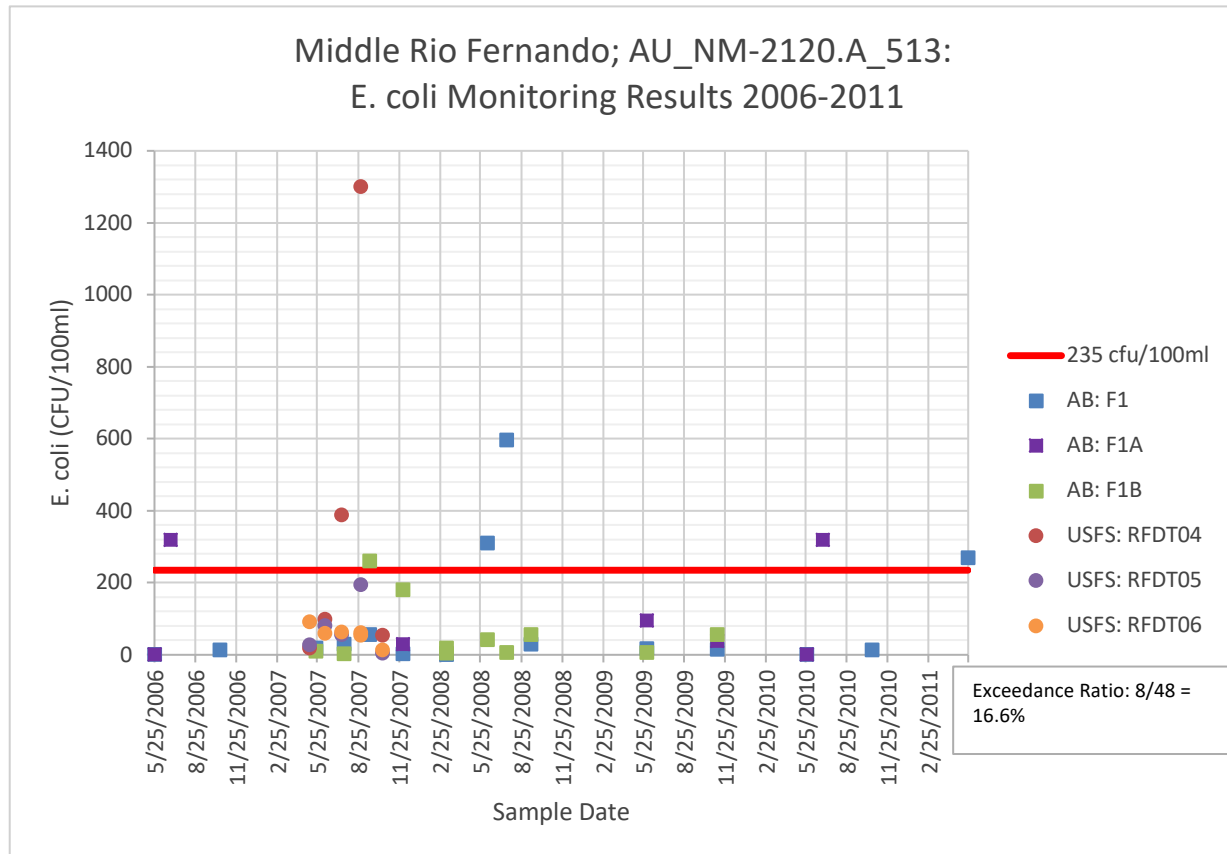
Figure 4-2: E. coli results from USFS and AB at three sites over the course of a five-year period.

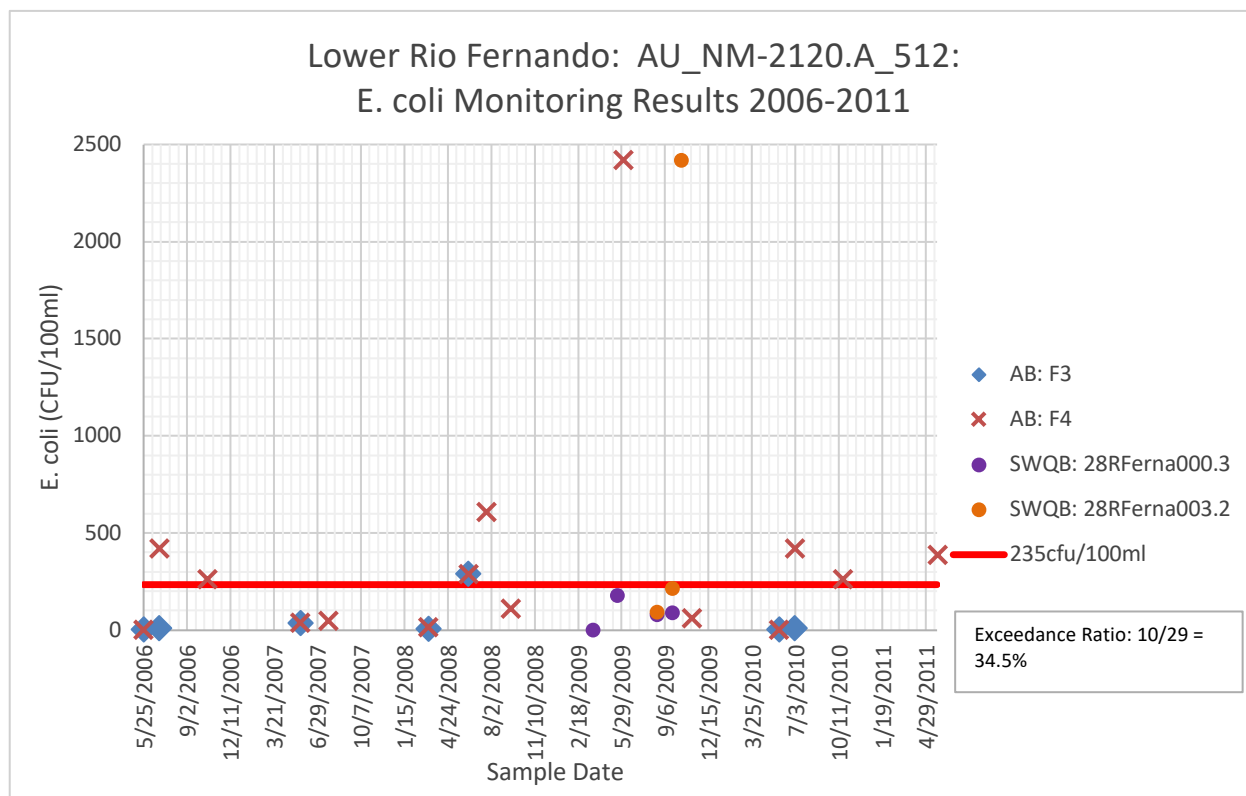
Figure 4-3: E. coli results from AB and SWQB at three sites over the course of a five-year period.

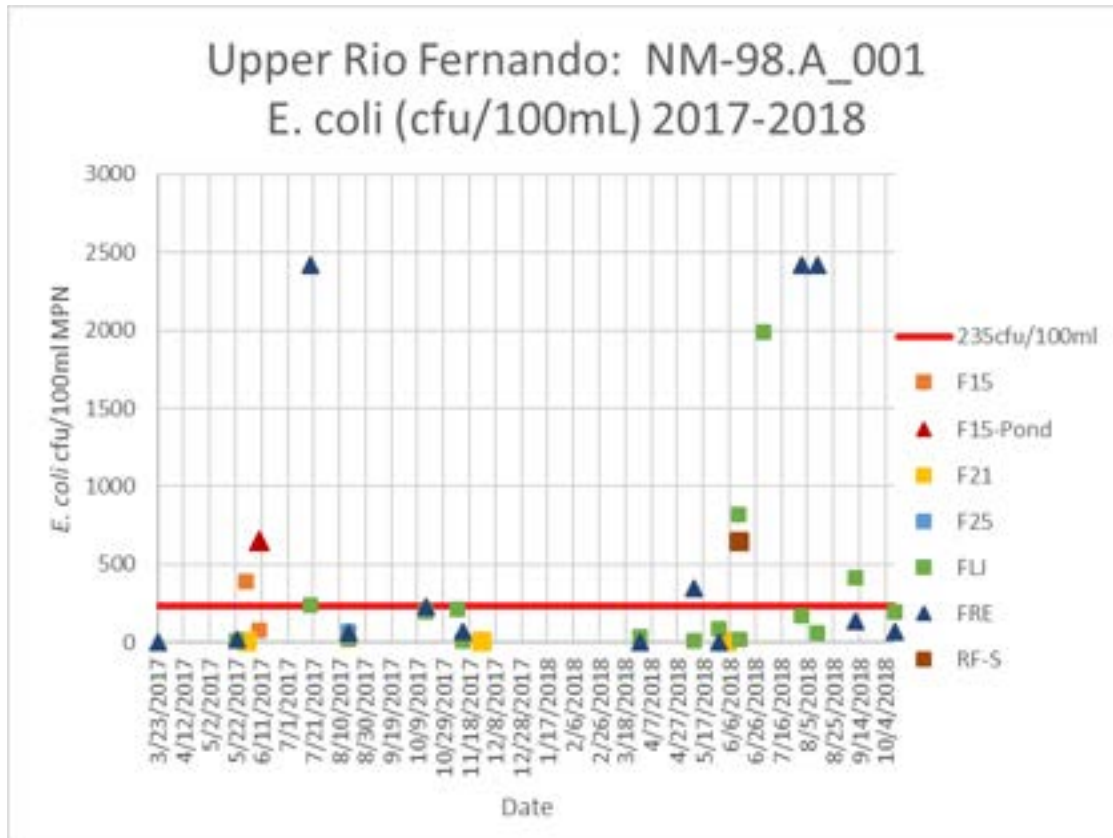
**Figure 4-8: Upper Rio Fernando de Taos watershed *E. coli* results from March 2017 – October 2018.**

Samples were collected every four to five weeks at six sites from March 2017 – October 2018 in the upper segment of the RFdT. In total, 40 *E. coli* samples were collected during this monitoring period. Of the 40 samples, 11 (27.5%) exceeded the single sample 235 CFU/100ml water quality standard. Review of data show a strong seasonal pattern of *E. coli* exceedances in this reach. All exceedances occurred during summer months with two in May, three in June, three in July, two in August, and one in September. Federal grazing in this reach of the watershed typically occurs from mid-June through September for a period of 107–120 days. Exceedances that occur prior to livestock presence in this area may be attributed to other potential sources such as wildlife, waterfowl, pet waste or older livestock fecal deposits. To better characterize the sources of *E. coli* in this segment, two sites FRE and FLJ, were selected as sample sites for the MST Study to estimate contributions from different source animal species or groups.

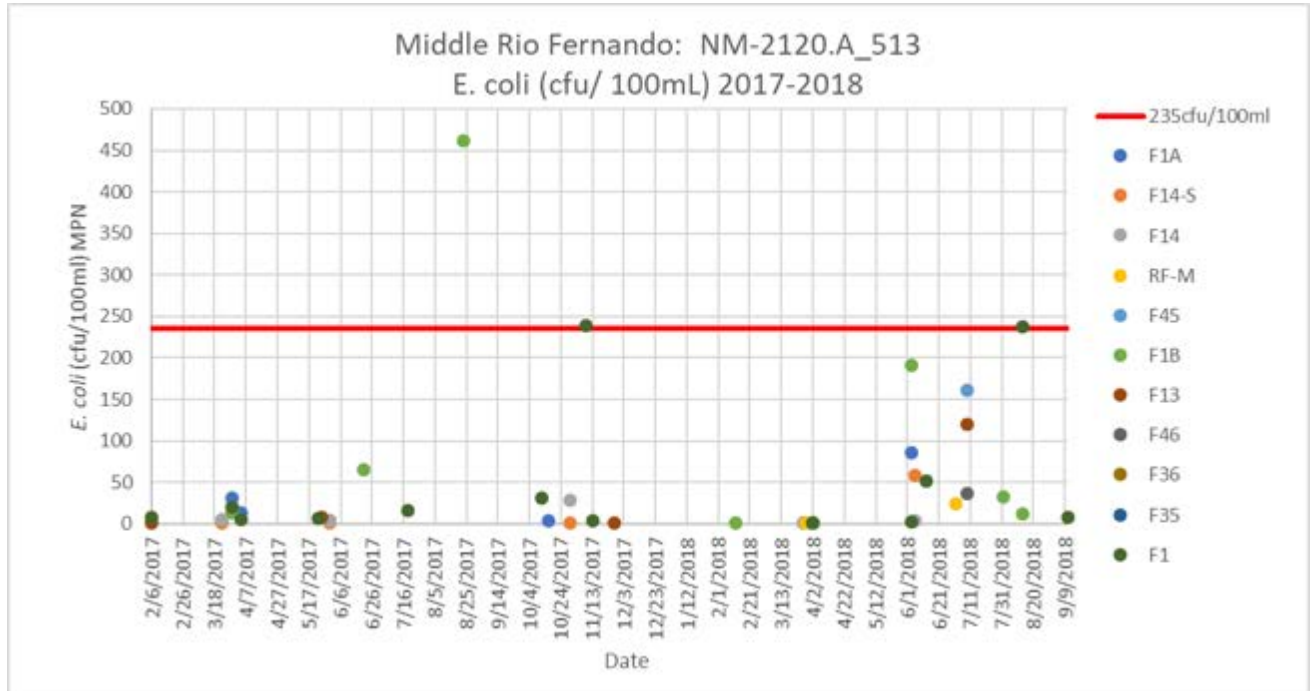
Figure 4-8: Middle Rio Fernando de Taos *E. coli* results.

In the middle segment of the RFdT, samples were collected every four to six weeks at eleven river sample sites. Sampling of this segment occurred from February 2017–September 2018. In total 46 samples were collected at eleven sites. Of the 46 samples, 3 (6.5%) exceeded water quality standards. These exceedances occurred at the F1 and F1-B sites. The two exceedances at the F1 site occurred at 11/9/17 and 8/13/18. The observed exceedance at F1-B occurred on 8/23/17. Due to the low number and infrequency of exceedances in this segment of the stream, no sites were chosen for the MST Study.

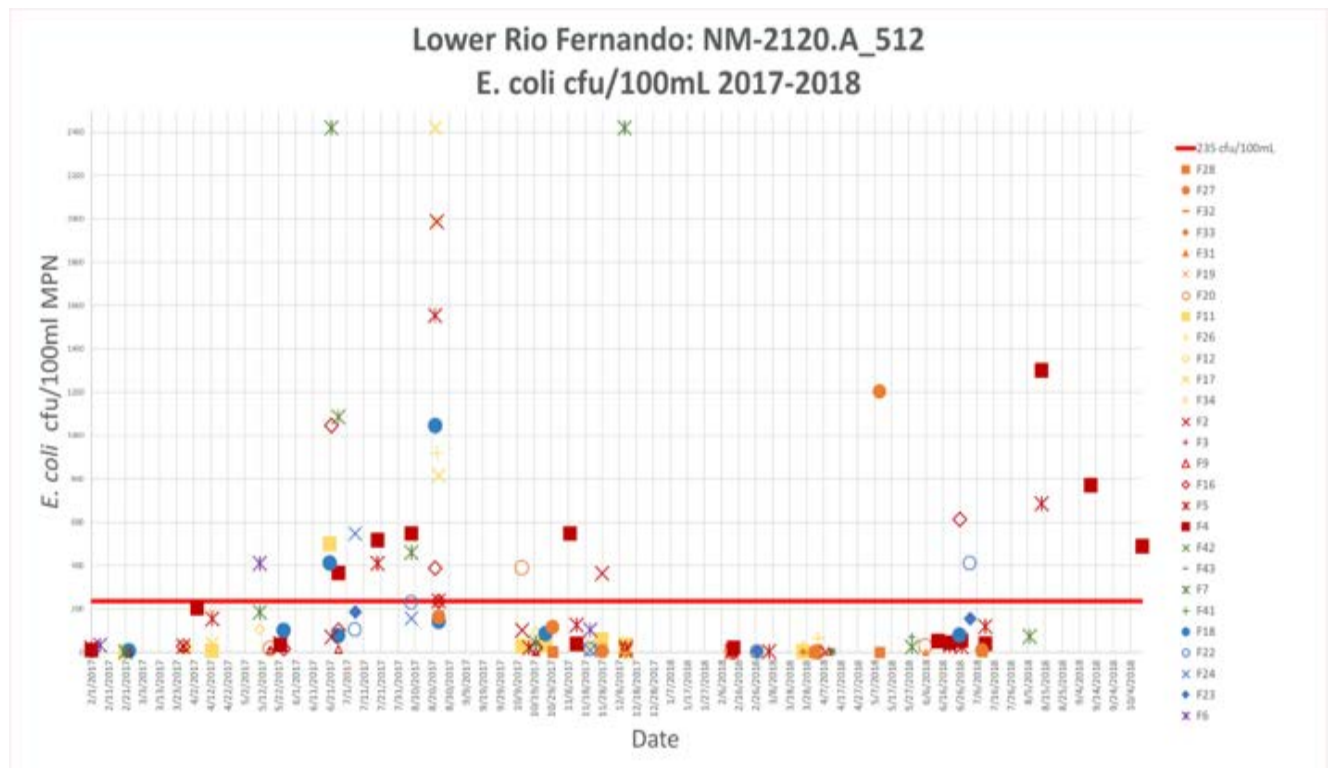
**Figure 4-9: Lower Rio Fernando de Taos *E. coli* results from February 2017 – October 2018. Sample sites are grouped by color according to catchment area and listed in order from the top of the lower watershed at the mouth of Taos Canyon (F28) to the confluence with the RPdT (F6).**

Of the Rio Fernando de Taos’ three segments, the lower segment was sampled the most intensely. Sample collection on this segment occurred from February 2017 to October 2018. Samples were collected at 27 sample sites. During the 2017–2018 monitoring effort, 159 samples were collected within this segment. Of the 159 samples, 32 (20.1%) exceeded water quality standards. 26 exceedances occurred during summer months with 2 in May, 7 in June, 4 in July and 13 in August. Other exceedances occurred during the fall with 1 in September, 2 in October, 2 in November and 1 in December. Review of data show exceedances occurred most frequently at the F4 (7), F7 (4), F5 (4) and F16 (4) sites. Three sites from this segment, F4, F16, and PS3 were selected for the MST study due to the number of exceedances observed during this and prior monitoring efforts.

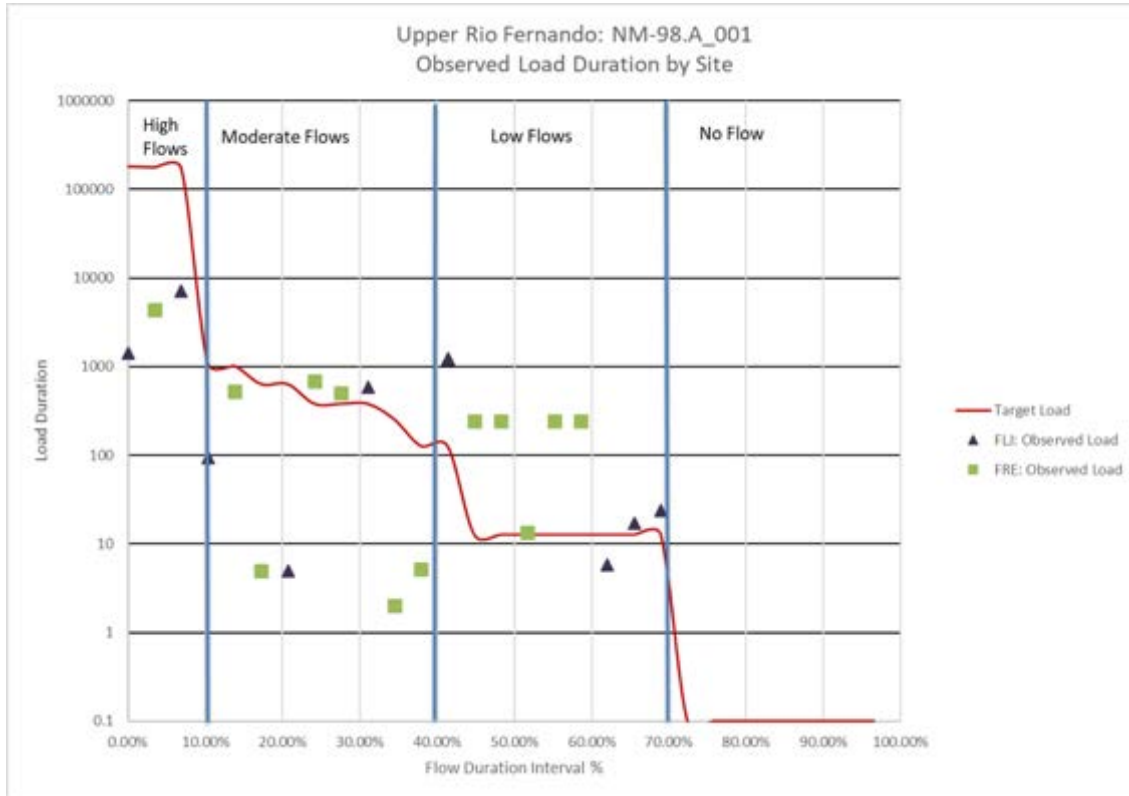
**Figure 4-15: Upper Rio Fernando de Taos, Assessment Unit: NM-98.A\_001 observed load duration by site.**

Exceedances observed at the FRE sample site during low flows occurred on 7/19/2017, 8/1/2018, 8/13/2018 and 9/11/2018. As stated above, rain events occurred prior to the 7/19/2017 as well as the 8/1/2018, 8/13/2018 and 9/11/2018 sampling events. Permitted grazing of livestock does occur in the catchment area during these dates and therefore livestock as well as wildlife are likely sources of *E. coli* observed in the stream during these sampling events. **Fresh evidence of cattle activity was documented in the data sheets on 7/19/17, 8/1/18, and 9/11/18. Cattle were meant to be in this area from August 31–October 6.** The timeframe was longer than 10 days this year due to a fencing project that was in process. The fence will be back up following the 2019 grazing season. Because of precipitation prior to the sample events, it is likely runoff carried fecal matter from both livestock and wildlife within the catchment area to the stream.

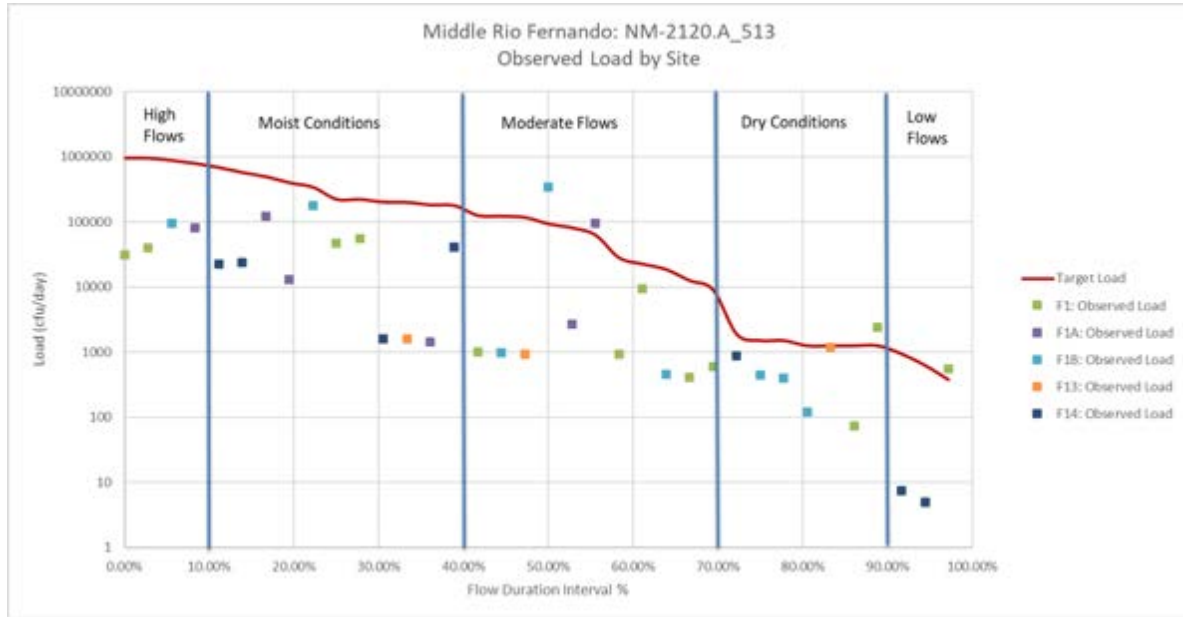
Figure 4-12: Middle Rio Fernando de Taos: Assessment Unit: NM-2120.A\_513 observed load duration by site.

Exceedances observed at the F1A and F1B site occurred on 6/4/2018 and 8/23/2017 respectively during moderate flow conditions. Precipitation data show there were rain events prior to both sampling dates at the F1A and F1B sites, indicating that natural sources of fecal matter from livestock and wildlife and or anthropogenic sources from campgrounds, roads/bridges/culverts, impervious surface, and other stormwater runoff may have been picked up and carried by runoff within the catchment area.

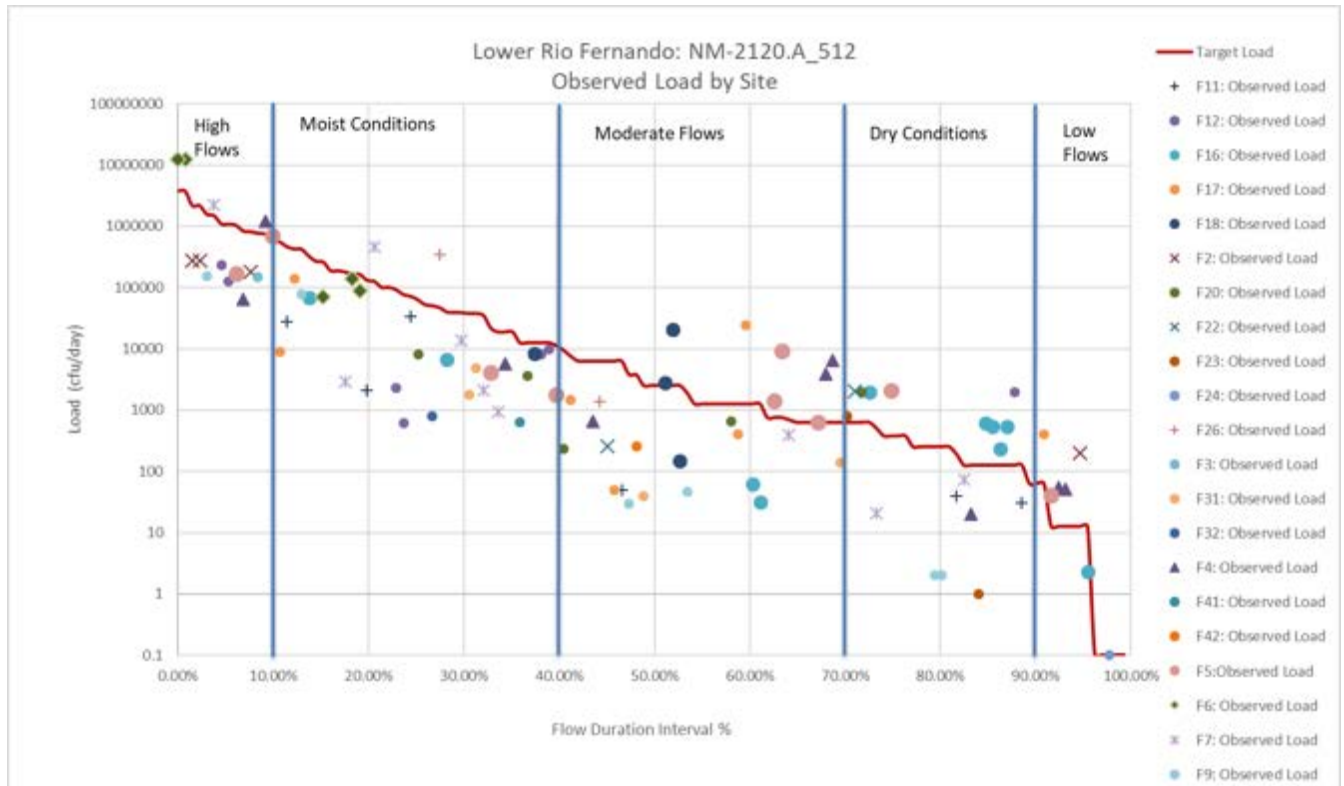
Figure 4-13: Lower Rio Fernando de Taos: Assessment Unit: NM-2120.A\_512 observed load duration by site.

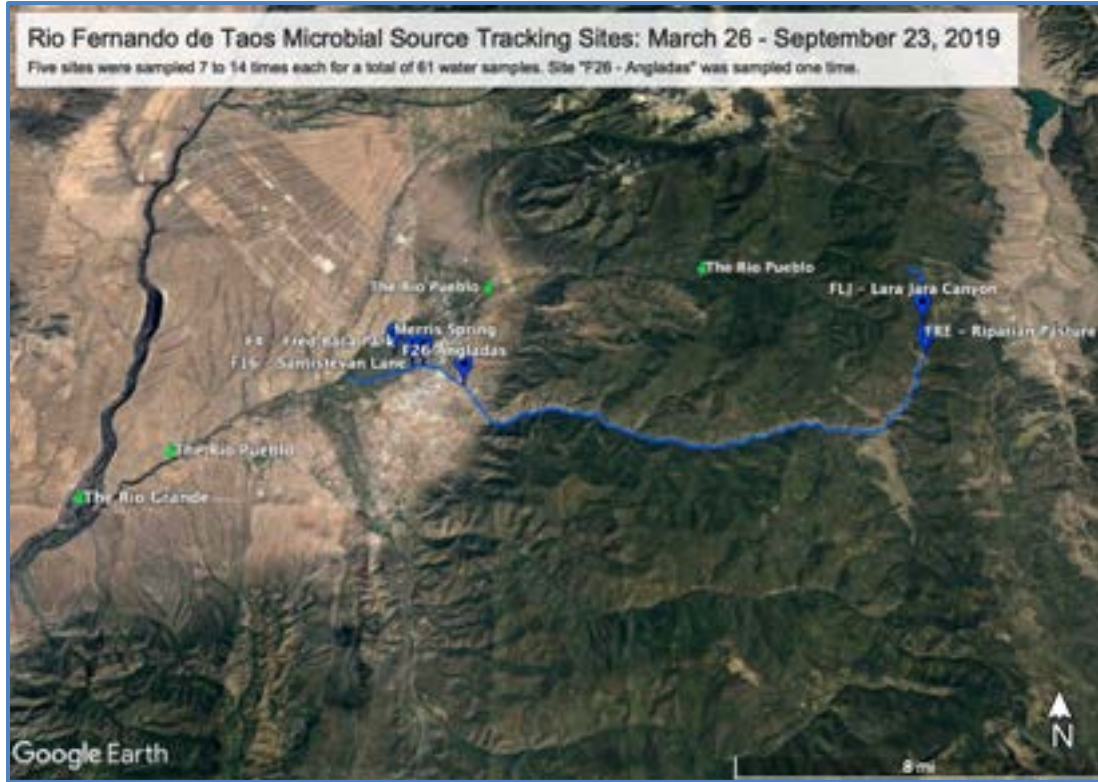
Figure 4-19: Map of Microbial Source Tracking Site Locations

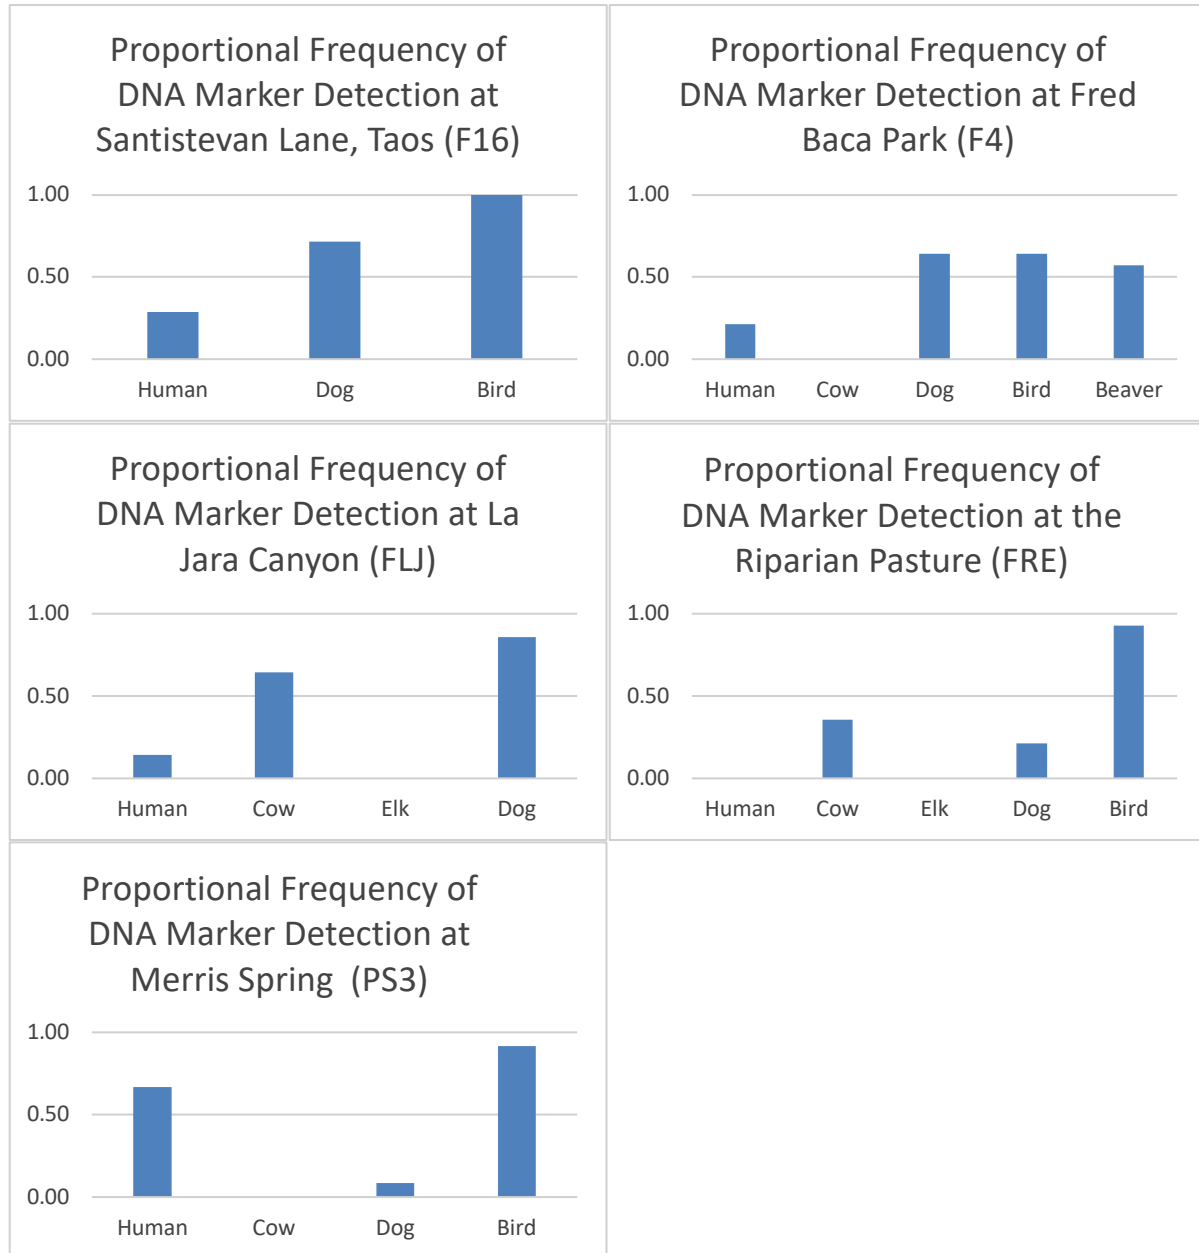
**Figure 4-22: Proportional frequency graphs at each of the five MST sample sites.**

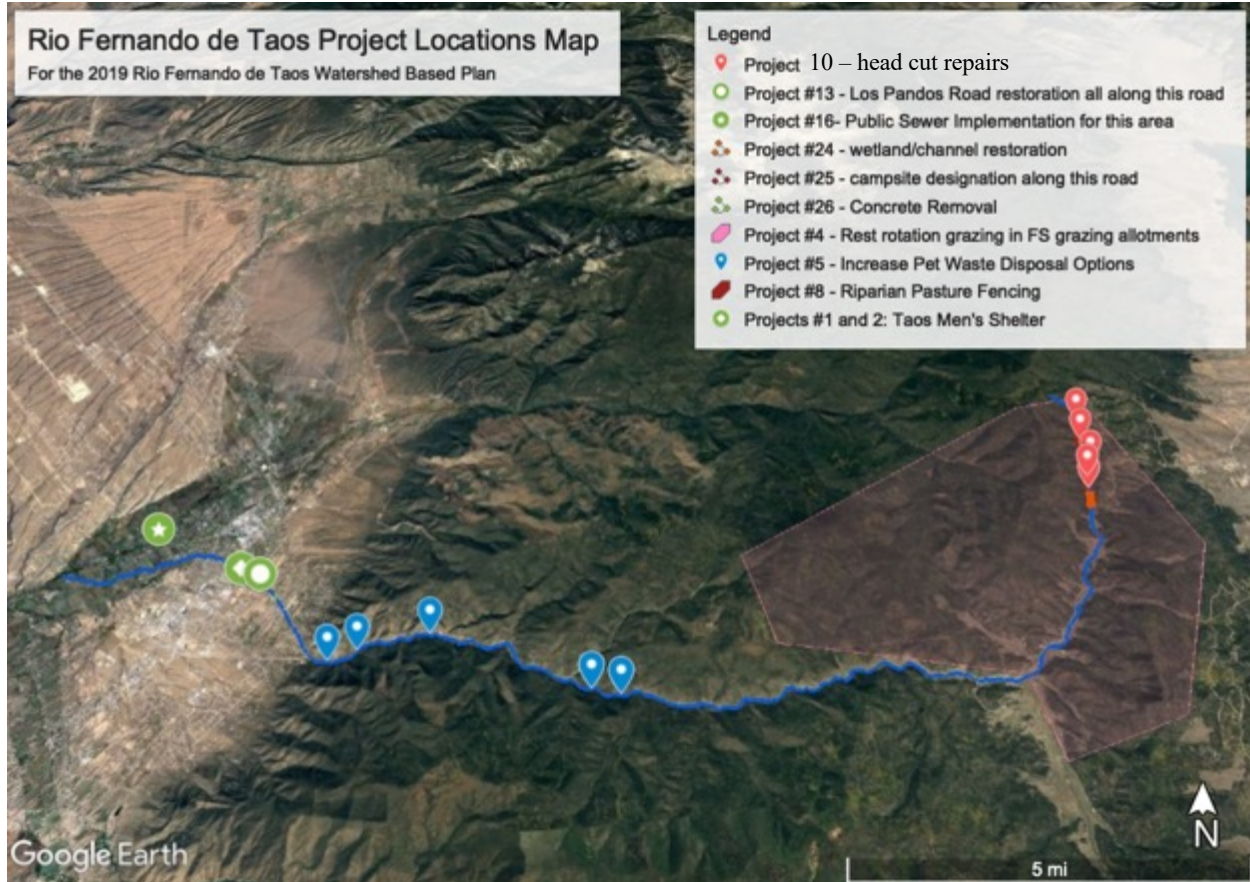
Figure 6-2: Map of each project using project numbers from the Project Table (Figure 6-1)

Projects with specific locations are shown on this map. Projects without specific locations can only be found in Figure 6-1. The upper, middle, and lower sections are separated by color.
