**2022 Water Sentinels Rios de Taos
Water Quality Sampling Report**
*Rio Hondo, Rio Fernando, Red River, Rio Pueblo de
Taos, and the Rio Grande*

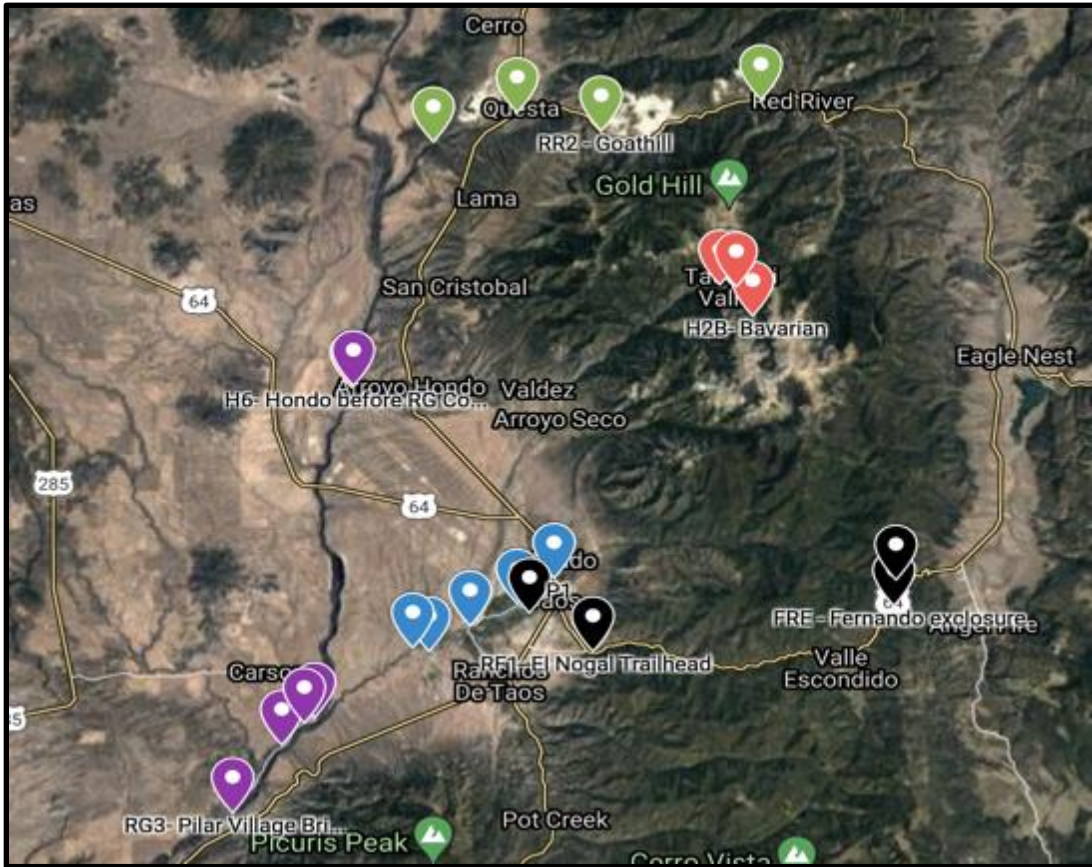
Figure 1: Map of Taos, NM area water sampling locations.

Surface water quality sampling was conducted in the upper Rio Grande watershed in July, August, and September 2021. Samples were collected from 5 sites in the Rio Hondo, 5 sites in the Rio Pueblo de Taos, 5 sites in the Rio Fernando de Taos, 4 sites in the Red River, and 5 sites in the Rio Grande and 6 sites on the Rio Embudo in September only. (Appendix A and Appendix C). Below is a detailed map of the water collection sites. Green = Red River, Red = Rio Hondo, Purple = Rio Grande, Blue = Rio Pueblo, and Black = Rio Fernando. [Find embudo map from robert](#)

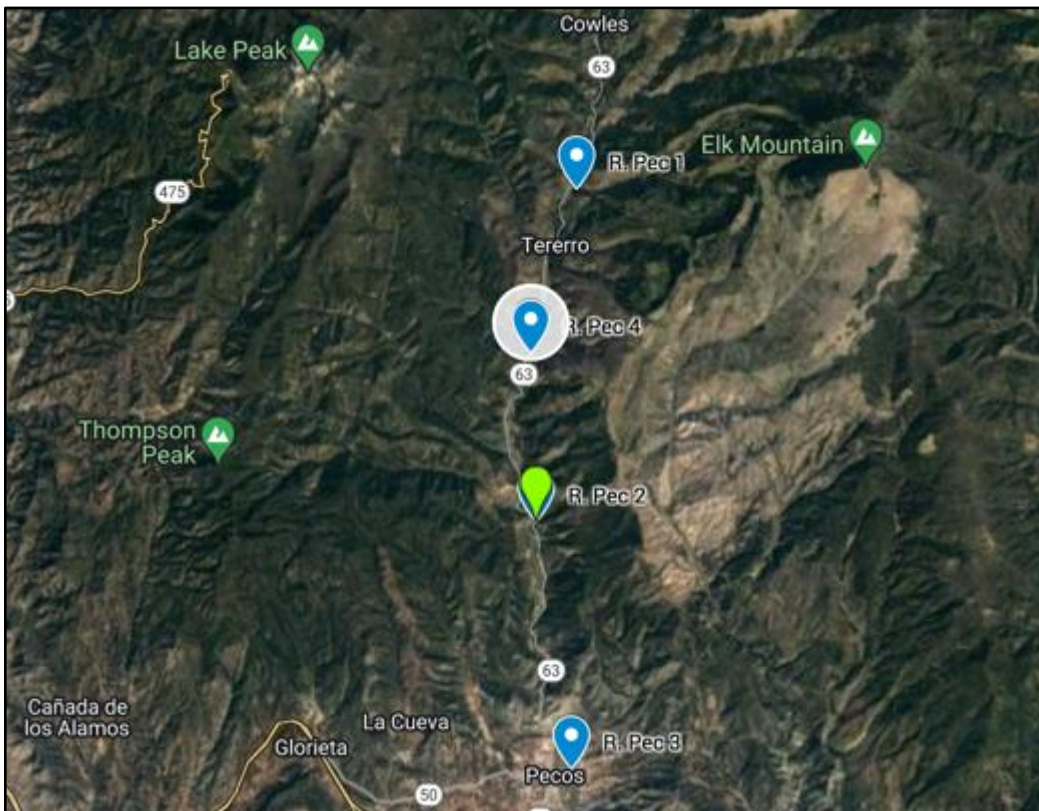
Figure 3: Map of Pecos River sampling locations.
