STORMWATER MANAGEMENT

From Catch Basins to Culverts:

Two Counties Tackle Two Very Different Challenges

Angus W. Stocking, L.S., and Linda Keairns

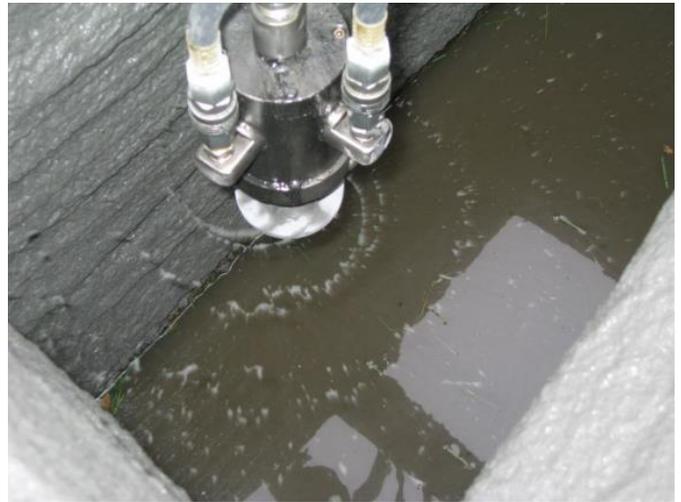
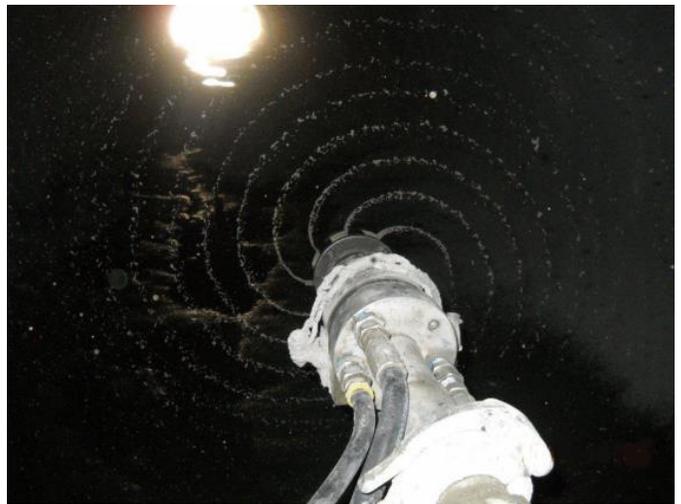
Figures 1 and 2. Flowable Engineered Fine Aggregate Composite Concrete is centrifugally cast in vertical and horizontal structures

PERMACAST® MS-10,000 and PL-8000 are fine aggregate composite concrete (FACC) materials, engineered specifically for application in either vertical or horizontal structures. They rely on precisely graded quartz sands, non-metallic fibers, and other complex admixtures to achieve a unique blend of strength and other desirable properties that make them excellent choices for catch basin, wet-well, lift station, manhole, horizontal pipe, and sewer rehabilitation.

- Thixotropy:** “MS-10,000 and PL-8000 have the ability to become fluid—i.e. experience a viscosity decrease—when stirred or shaken,” explains Kampbell. “That produces a flowable mixture that can then be pumped long distances. And once it’s cast into position onto the wall of a structure it thickens

up quickly, providing sufficient ‘hang-time’ for the wet concrete applied to take its initial set. Getting the thixotropy right is so important—it helps the contractor apply consistent layer thicknesses, it enables good flow into low areas like corrugations and open joints, and it means the initial layers stick well to substrates, providing a dense foundation for the new concrete liner with the host pipe structure.”

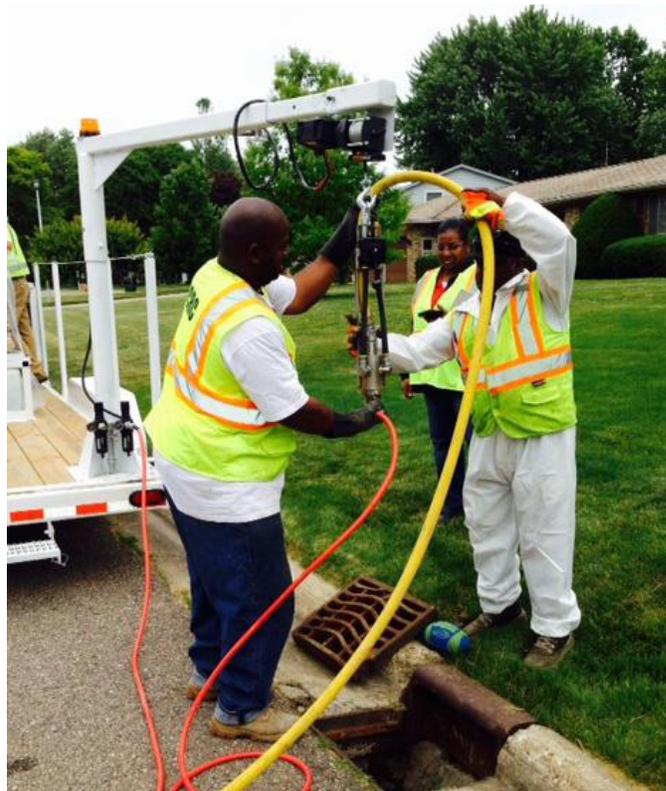
Figure 4. GCRC Crew Lowers Spincaster into Catch Basin

The heart of the PERMACAST® system is the bidirectional spincaster, a technology pioneered by AP/M Permaform and used in several applications, including manhole rehabilitation and trenchless centrifugally cast concrete pipe (CCCP) storm sewer rehabilitation. The spincaster sprays on thin, smooth layers of high-strength cementitious mortars. In Genesee County, GCRC uses a winch to lower the spincaster into 36-inch-by-48-inch (typical, some are deeper) brick catch basins, using multiple passes to spray on concrete layers about an inch and a half thick. For this application, AP/M Permaform’s MS-10,000 is used, a fine aggregate, waterproof, corrosion-resistant cementitious liner that adheres tightly to the brick substrate, forming a monolithic new “pipe” that is sealed and structurally sound, independent of the original catch basin. “The seamless and structural aspects of the rehabilitation are excellent for our brick catch basins,” says Dellaposta. “Really, the end result is a much stronger and better catch basin than the brick basins were even when they were new.”

total failure. We inspect and clean them as needed, with the spinwasher on the trailer, then do minor repairs like filling voids and replacing loose block. If there are any inlet or outlet tubes we cover them with disposable bowl covers before spraying,” he says. “When all that’s done, we hook up the machines and mix the cement. Most basins take about five bags of MS-10,000, and that usually takes about five passes with the spincaster to get even coverage between an inch and an inch and a half thickness. Then we remove the bowl covers, replace grates, and we’re done.” Quality control is straightforward; by counting the bags of mortar used, Nims has a good idea of the total volume of material used, and a simple gauge can be used before the material cures to spot check layer thickness as needed.

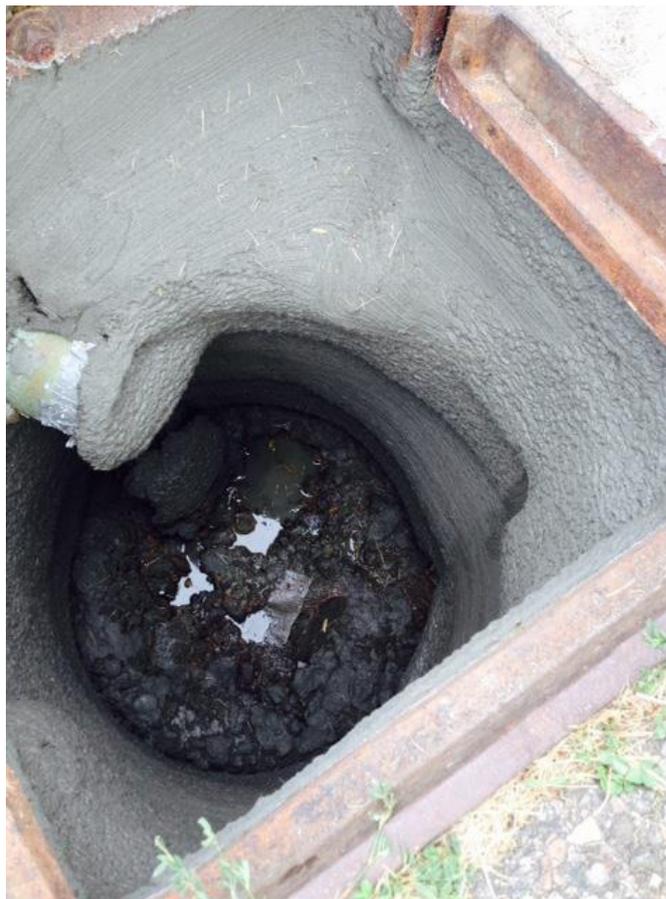
Figure 5. Structurally rehabilitated catch basin

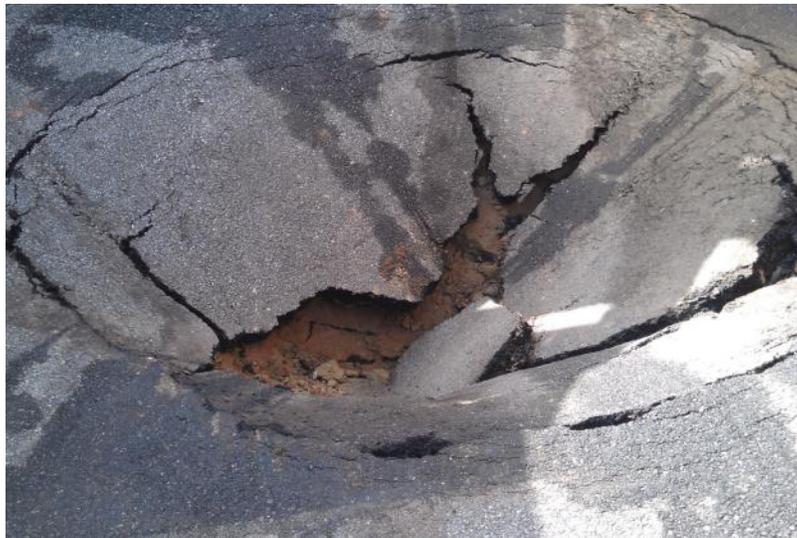
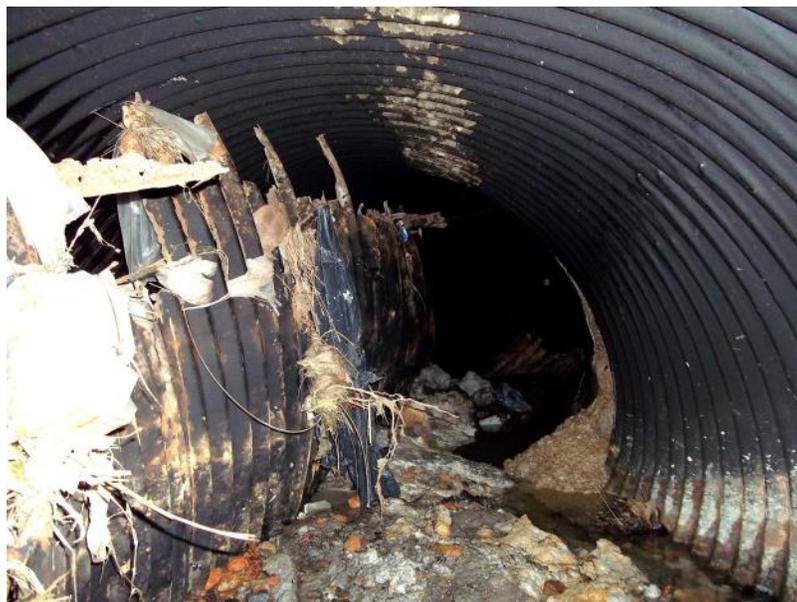
Figures 6 and 7. Parking lot collapsing above ground; Culvert sidewalls curling into pipe interior

In one case, a 66-inch, 20-foot-deep, 220-foot-long CMP culvert was failing so dramatically that parking lots and commercial buildings overhead were subsiding noticeably and had to be monitored throughout subsequent rehabilitation.

Inspection revealed inverts that were completely corroded, side-walls that were curling up into the pipe interior, and some collapsed pipe. And after discovery, the failure accelerated. “From quote to award, the culvert had collapsed even further,” says Anita Clyne, President of Utility Asset Management Company (UAMC). “That’s when we realized typical procedures would not be enough for this project.”

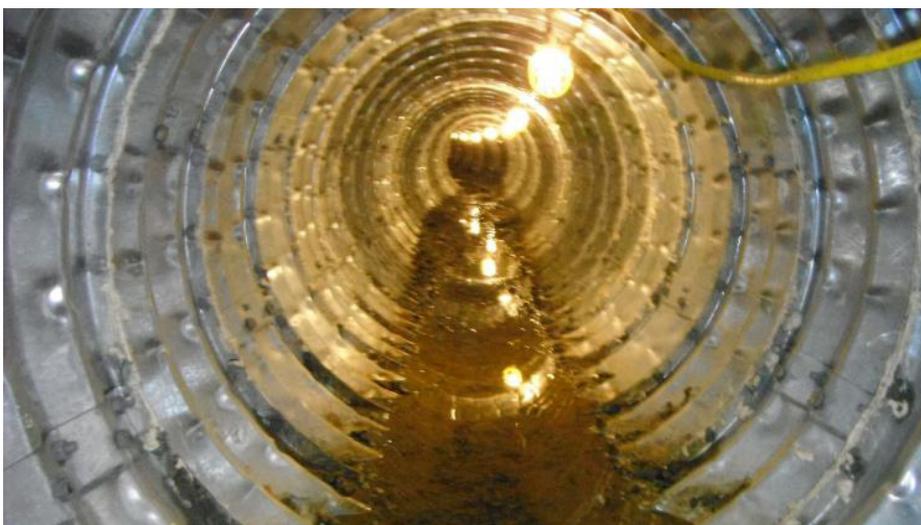
Figure 8. Phase 1: Tunnel liner plates installed

In phase one, 54-inch tunnel liner plates were used to stabilize the culvert structurally. These are four-part steel rings, 18 inches wide, that were assembled within the pipe. “First, we had to cut out curled-in pieces of the old culvert by hand,” explains Clyne. “Then we assembled the liner plates inside the culvert, section by section—basically, we were building a new pipe, 18 inches at a time. And meanwhile, cars and trucks were driving by in the parking lot above us.”

The liner plates’ four arched sections were bolted together manually, and each completed section created a new 18-inch safe zone for workers, who then repeated the process...146 times. After the new bolted-together “tunnel” was completed, the void between the liner

plates and the existing 66-inch CMP (what was left of it, anyway) was filled with injected grout. It was tedious work in a cramped space but it was safe and effective; phase one was completed with no injuries and no further subsidence of overhead buildings, and at least the culvert was stable.

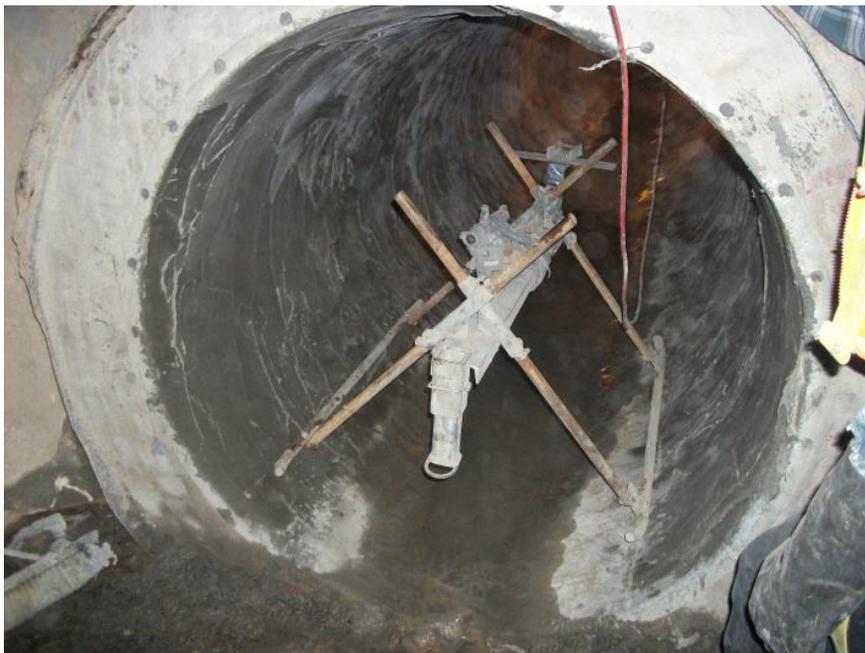
Figure 9. Phase 2: Spincasting

Phase two was to create a smooth, watertight, structurally-sound pipe within the new tunnel liner plates and to smooth out the corrugations created by flanges. For this phase, UAMC utilized CentriPipe, a trenchless repair technology they have had good success with on previous projects. Developed by AP/M Permaform, CentriPipe is a centrifugally cast concrete

pipe (CCCP) technology that relies on a computer-controlled spincaster that is inserted into round, large-diameter pipes, spraying on thin layers of fine aggregate composite concrete (FACC) as it is pulled back through the pipe at precisely calculated speeds.

In the Forest Parkway project, UAMC began by hand troweling grout to fill in flange gaps and to create a smooth invert so that the CentriPipe spincaster could be pulled back without jerking. An engineered 1-inch thickness of AP/M Permaform's PL-8000 material was then applied, completing the culvert rehabilitation.

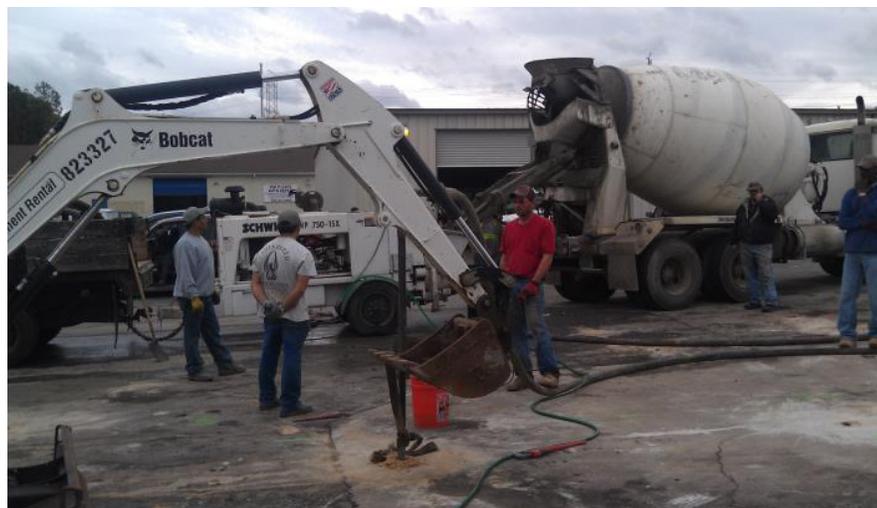
Figure 10. Phase 3: Soil stabilization with grout injection

The third and final phase involved addressing the cause of the dramatic failure—the extremely unstable soil surrounding the pipe. To prevent similar problems for the rehabilitated culvert, CCWA called for stabilization of the surrounding soil with cementitious grout, injected until refusal.
